EMERGENCY AIRWORTHINESS DIRECTIVE

DATE: August 15, 2006
AD #: 2006-17-51

Send to all U.S. owners and operators of Agusta S.p.A. Model AB139 helicopters.

2006-17-51 AGUSTA S.p.A.: Directorate Identifier 2006-SW-20-AD.

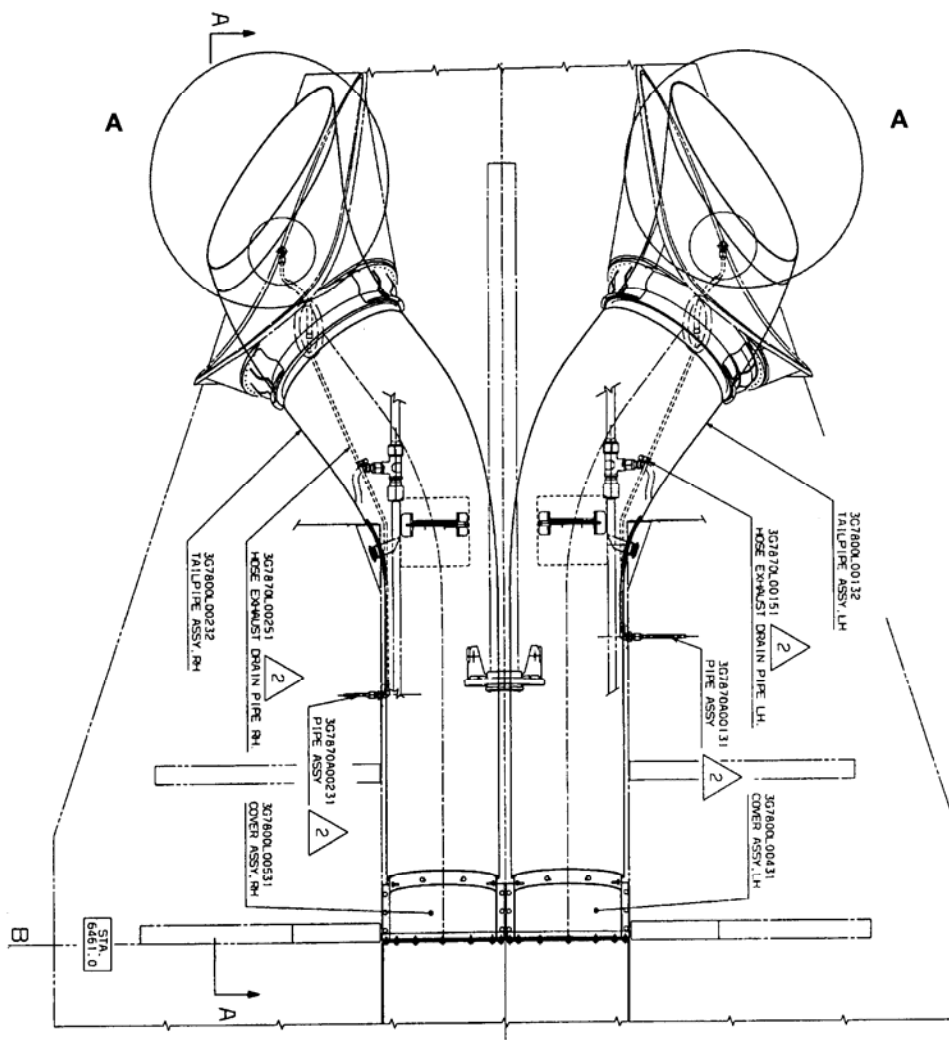
Figure 1

This Emergency Airworthiness Directive (AD) is prompted by several reports of tailpipe assembly cracks. This condition, if not corrected, could result in a fire due to the structure in the cowl area overheating, separation of a part or a tailpipe assembly, and subsequent loss of control of the helicopter.

The reason for the cracked tailpipe assemblies has not been determined and is still under investigation.

(2) Inspect the structure surrounding each tailpipe assembly for overheating. If you find areas of overheating, inspect for heat damage to the surrounding structure. Inspect for overheating in the area of each tailpipe assembly outside the cowling. Inspect the internal part of each tailpipe assembly in the areas depicted in Areas A, Figure 1, of this AD.

(i) Clean the end of each tailpipe assembly with a cloth. While applying slight pressure on it, inspect for a crack using a flashlight.

(ii) Inspect each tailpipe assembly toward the centerline of the helicopter for a crack using a flashlight.

(iii) Inspect each tailpipe assembly toward the outboard side of the helicopter for a crack using a mirror and a flashlight.

(3) If you find a crack, before further flight, replace the tailpipe assembly with an airworthy tailpipe assembly.
